Section 19 Flood and Water Management Act 2010

Wickham Market Flood Investigation - Storm Babet October 2023

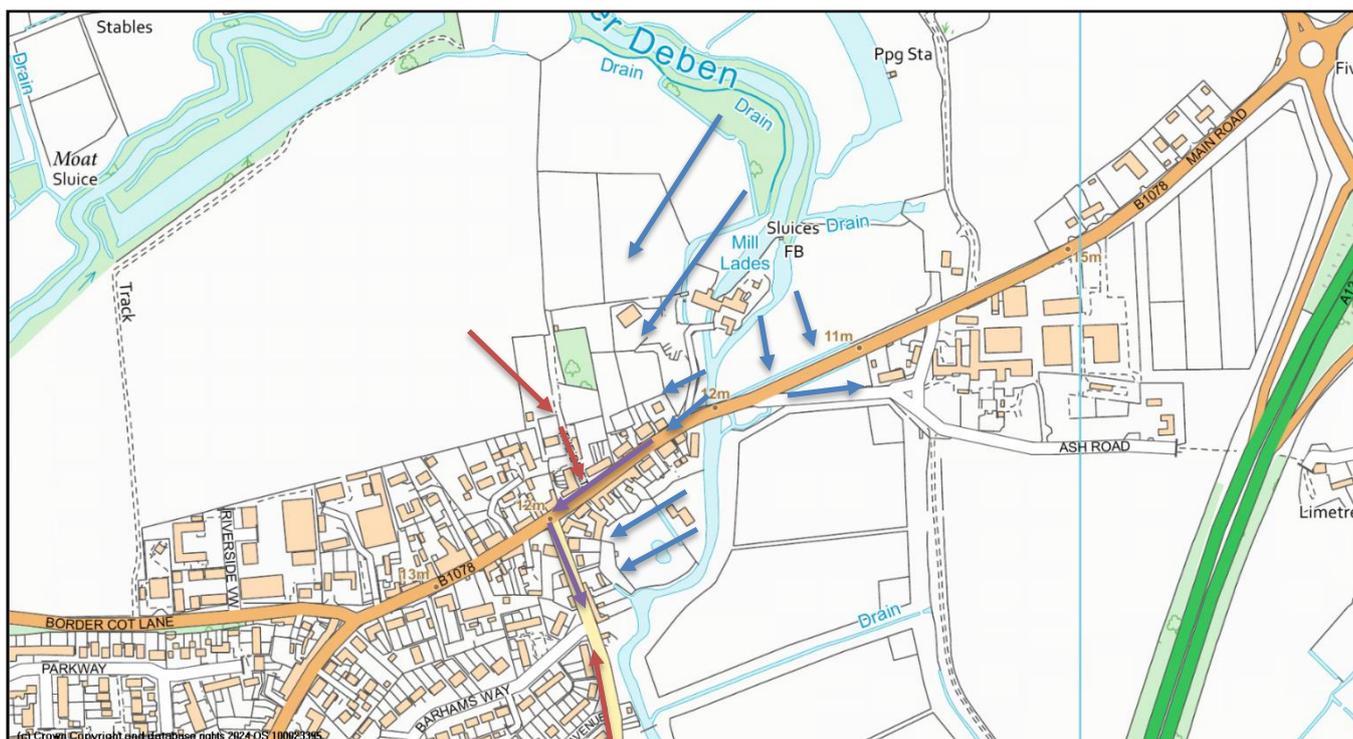
Figure 7 - Event flow paths (north)

The northeast corner of Wickham Market is situated in close proximity to the River Deben and therefore susceptible to flow paths that overtop the riverbank. On the 20th October, reports in the area suggested the overtopped river was a significant cause of the flooding within this location. In addition, heavy rainfall earlier in the morning was reported to have caused the highways drainage to become overwhelmed before the riverbank was breached. At least 48 Properties are known to have been affected in this area.

Additionally, overtopping of the river just north of the main road bridge caused a flow path across the access road to the Deben Mills heading west and south along the highway, affecting properties on both sides of the High Street. The highway flow path continued down the road towards Spring Lane and entered properties through the front doors, which was exacerbated by passing vehicles causing bow waves as they continued to pass through the flood water. On the north side of the High Street, reports suggested that the flood water was flowing down the highway during most of the morning of the 20th October and later in the afternoon a torrent of water came across the gardens to the rear of the properties causing internal flooding. This falls in line with other reports suggesting the surface water was flowing down the highway well in advance of the river overtopping.

Further overtopping of the river to the south of the High Street bridge caused flood water movement west towards properties on the south of the High Street and east of Spring Lane, consequently causing flooding to the front and rear of these properties.

Flood water which overtopped the eastern bank of the river, north of the mill, travelled south and west and affected properties on Ashe Road. Water flowed over the B1078, travelled down Ashe Road and into properties from the front.

Reports taken by EA CIO teams shortly after the event, suggest an additional water source was coming from surface water flowing off the fields from the northeast of the High Street. This flow path was less significant than the overtopped river flows but added to the flood water exacerbating the event. Additionally, a surface water flow path was observed by residents to have been coming from the fields to the south of King Edward Avenue and west of Spring Lane. This flow path was of a significant enough velocity that it caused erosion to the highway bank causing mud to slip onto the highway and create hazardous driving conditions. This flow added to the flood water on spring lane further intensifying the event.

Flood water caused further internal flooding to properties on Ashe Road, High Street, Spring Lane and the Deben Mill and Rackham's estates. Internal flooding reached levels of 60cm, and external flooding was measured through wrack marks at 100cm. Reports suggest that the significant flow of water in the area caused damage to brickwork and removed mortar, causing walls to collapse. Livestock had to be rescued from the area by residents and homeowners were evacuated from some properties that were surrounded by flood water.

The map below shows the main flow routes of the flood water in this area. It is important to note that following a site visit from the EA after the event, a significant build-up of silt in the main channel of the river has been identified adjacent to the B1078 road bridge over the River Deben. Investigations between Suffolk Highways

and the Environment Agency are ongoing regarding the removal of the silt to increase the capacity of the river channel under the bridge.

- Flood water from the Deben overtopping, flowed down High Street, Spring Lane and across Rackham’s and Deben Mills estates. Some flows were not in line with currently predicted flood risk.
- Highway drainage gullies became overwhelmed due to significant rainfall and water from overtopped river.
- Anglian Water assets were overwhelmed due to significant water volumes entering the system predominantly from the overtopped river Deben.
- Significant silt build up in the river Deben to the north and south of the main road bridge may have reduced capacity in the channel.
- Surface water flow paths from the north and south exacerbated the severity of the event.
- Possible attenuation opportunity on the fields to the south.

- EA and SCC to investigate possibility of removing silt build up near main road bridge
- Investigate the possibility of Natural Flood Management (NFM) in the fields to the north-west and south-west to try and prevent these secondary flow paths from having such an impact.
- Anglian water to investigate the capacity of the pumping station in the area to ensure it is of adequate size.
- SCC highways to investigate the possibility of increasing the capacity of the drainage network in the area

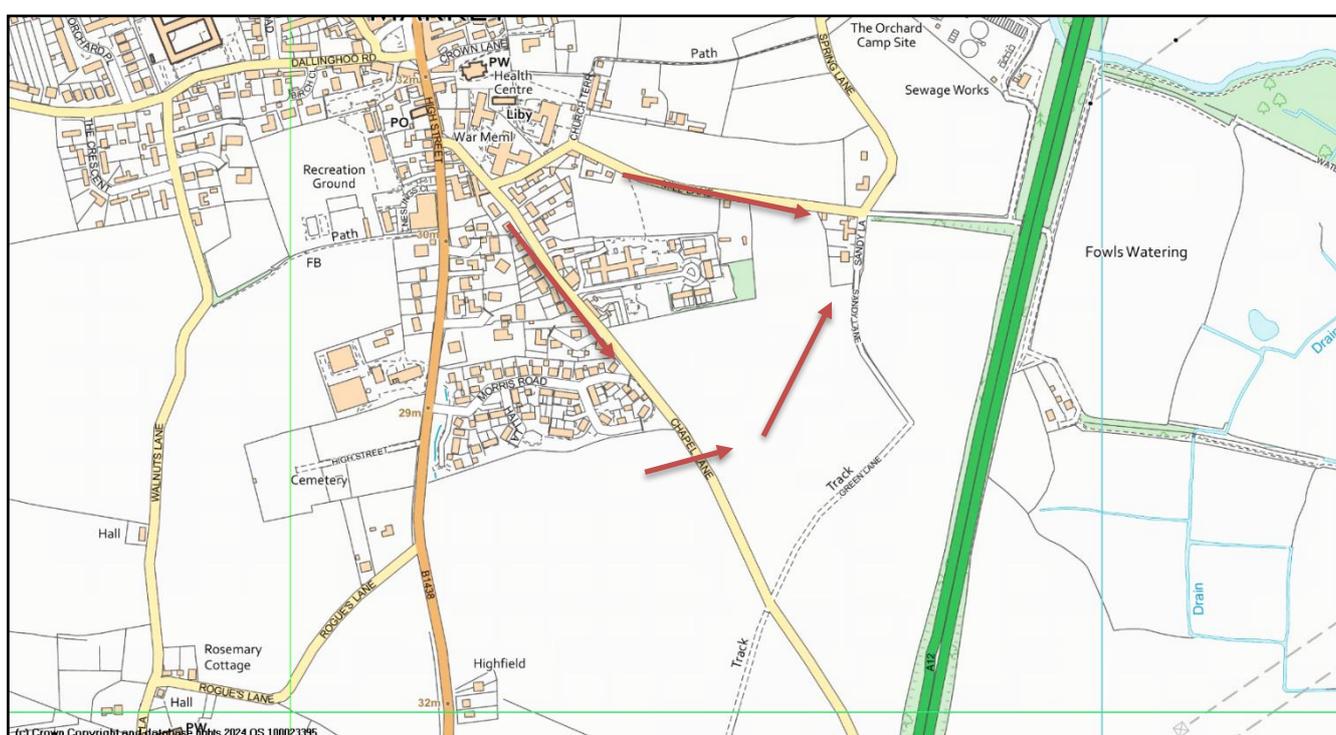
Figure 8 - Event flow paths (east)

The eastern area of Wickham Market was the least affected by the flooding, however Mill Lane, which runs east-west and Chapel Lane which runs northwest-southeast are some of the lowest points in the area and as such can act as a flow path for surface water. Historically, Chapel Lane is regularly affected by flooding events from surface water, and this was cited as a cause for concern at the planning stage of the Wickham Gate development.

Evidence suggests that surface water runoff from surrounding fields was the main cause of the flooding in this area, which is in line with predicted flood risk mapping.

There is an Ordinary Watercourse which runs adjacent to Chapel Lane to the east of the Wickham Gate development which was reported to have been overtopping during the event. Photographs obtained shortly afterwards show the watercourse retaining water and not flowing freely. It is possible that maintenance of this watercourse and

ensuring a good flow in this channel would have the potential to reduce the severity of a flood event in the future. The downstream route of this channel requires further investigation to assess potential flood risk.

Properties in Mill Lane were severely affected in the gardens, with external flooding causing damage to retaining walls and flooding exterior buildings. Internal flooding also occurred, although extents are not currently known.

- Mill Lane is a high risk area for surface water flooding and the sheer volume of water from rainfall is likely to be the main cause of the flooding in this area.
- Possible ordinary watercourse maintenance in the area will allow a better flow path for the water to escape.
- Possible natural flood management opportunity which may reduce flood risk in this area.

- Ensure correct maintenance of the watercourses in the area are regularly carried out and any issues/obvious blockages are highlighted to the relevant RMA/landowner/Parish as soon as possible.
- Investigate the possibility of NFM in field to the south of the area affected.

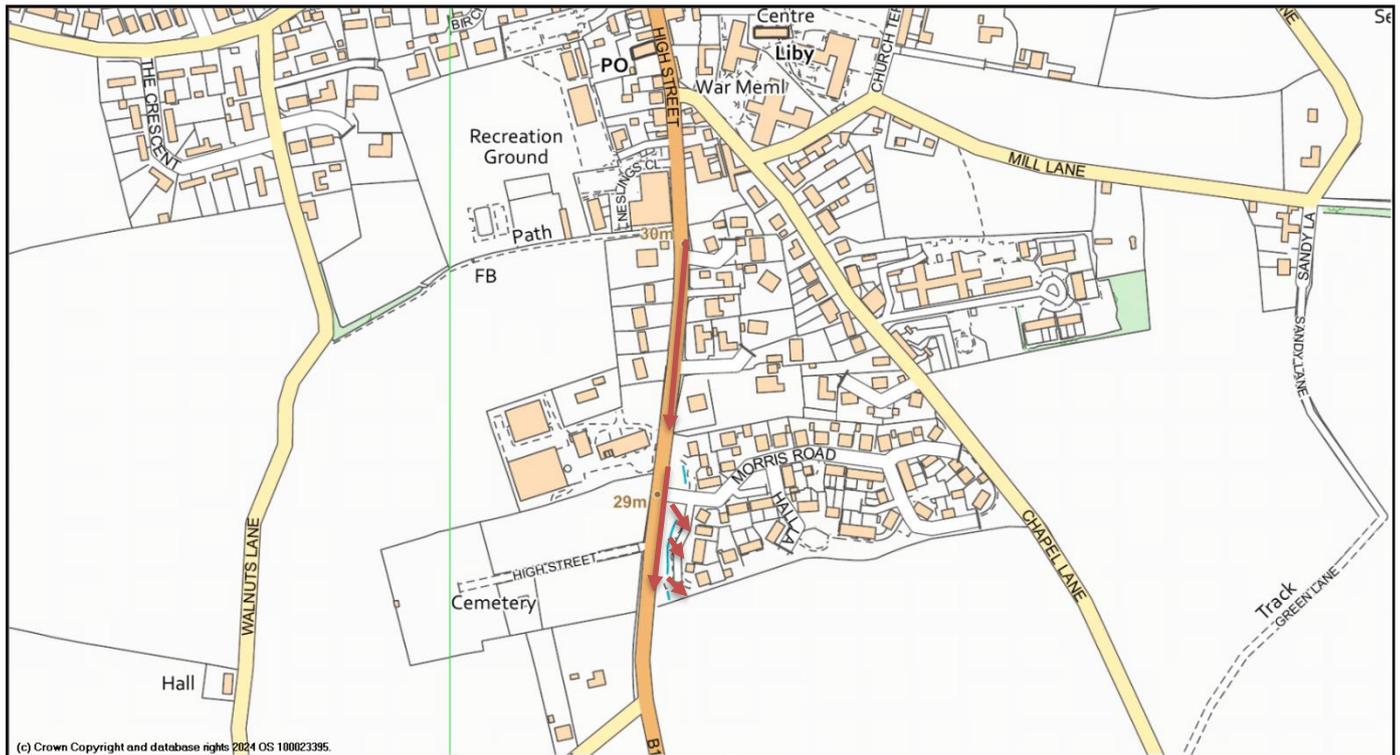
Figure 9 - Event flow paths (south)

The southern part of Wickham Market was affected by surface water flooding. A few properties are known to have been affected in the area. There are low spots on the west side of the High Street which surface water flows towards. Properties in this area were affected from significant rainfall and water running off the highway.

There is a significant number of highway drainage assets in this area, many of which may not have been operating at full capacity at the time of the event according to the highway authority's asset recording software. This could have led to an increase in severity of flooding in the area due to water not being able to drain away effectively. However, due to the significant volume of rain, even if the gullies were fully operational, they may not have made a significant difference as it is likely that the drainage network's design capacity was exceeded.

Properties on Morris Road are reported to have been affected. Little information is available for this area with regards to extents of the flooding, and it falls outside the area predicted to be at significant flood risk on the national maps. However, it is likely that flooding in these locations was from surface water from the High Street. It is likely flooding was exacerbated by a lack of fully functioning highway gullies just to the north of the affected area and possibly some difficulties draining away down the watercourse to the south which borders the field boundary. Works have taken place to this watercourse as part of the build of the new housing estates to improve the onwards flow.

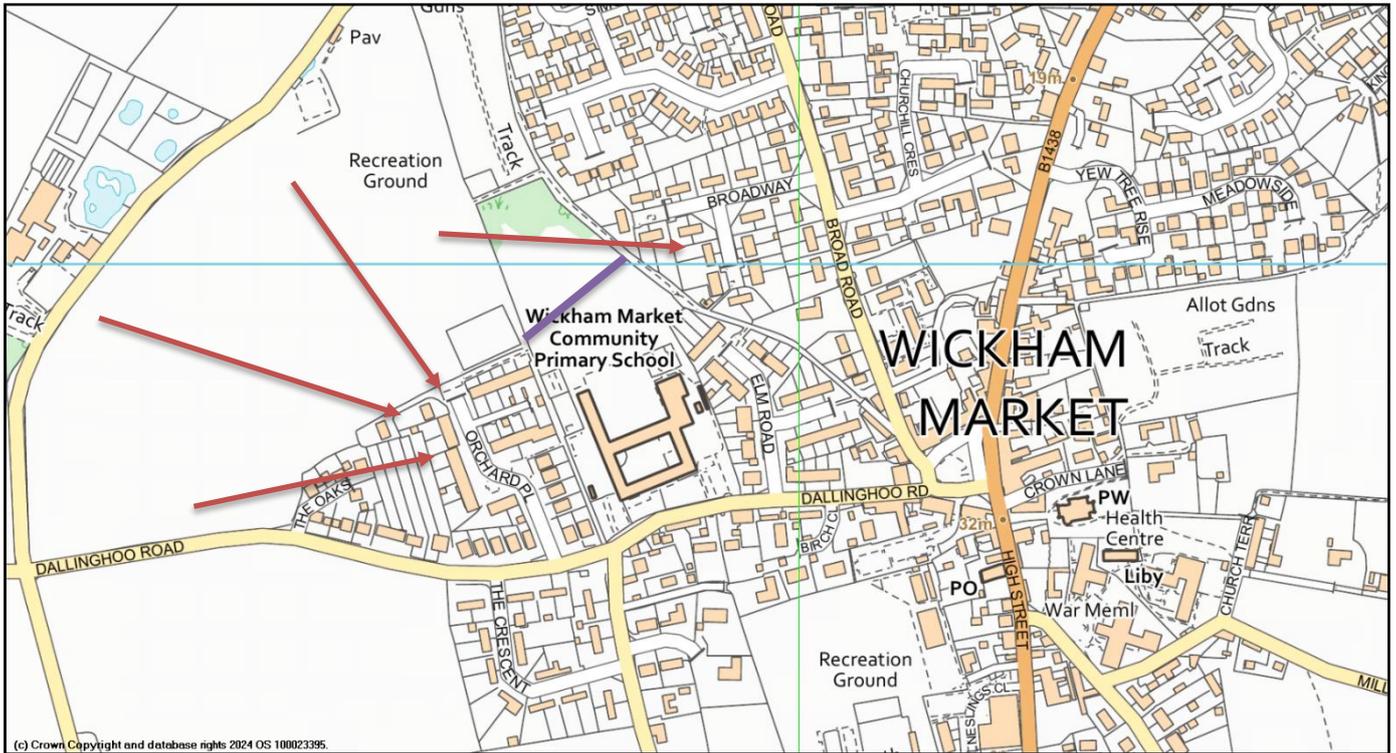
Figure 10 - Event flow paths (west)

the already saturated conditions and significant rainfall event, the speed of onset and volume of water overwhelmed the drainage system meaning the water could not get away quickly enough.

Residents reported that surface water from the Oaks development to the west is all piped into the watercourse bordering the field and may have contributed to the overall waterflow in this location. It should be noted that the high level of rainfall experienced during the event, it is likely that the watercourse would be overwhelmed regardless of additional connections. Looking into the historic planning records for the development, there is a controlled flow of 5 litres per seconds allowed by the design plans and some attenuation features present to ensure this is not exceeded. There are several factors which could prevent this from working at full efficiency, meaning there is no guarantee this flow was not a contributing factor.

Orchard Place was affected from the west by surface water runoff and reports suggest water entered some of the properties from the back. Other reports suggest overwhelmed or slow draining highways gullies caused the road to flood and enter properties from the front, as water spilled off the highway.

Water appeared to flow down the footpath located between two houses on the west side of Broadway. This flow overwhelmed the highway drainage network and caused the road to flood, accumulating at the lowest points of the local topography, between Broadway and Broad Road. The properties located on the east side of Broadway have gardens which are back-to-back with the properties on the west side of Broad Road. As the water flowed to the lowest point, it flooded the back gardens of these properties on both roads which then eventually entered the properties via the back doors. Due to the low-lying topography, the properties that were worst affected are identified as being at high-risk of flooding from surface water. Due to Broad Road being slightly higher, the flood water did not reach the highway on Broad Road.

- Significant rainfall resulted in large volumes of surface water runoff from the fields to the west.
- Highway infrastructure became overwhelmed causing the flood water to flow to the lowest points and pool.
- Lack of maintenance and possible issues with underground pipework to the north of Orchard Place may have impeded the flow of water away from the area.
- Highways gullies were inspected and found to be working correctly in February of 2023, but reactive work took place on the day of the event in specific areas.

- SCC/Landowner/Parish to investigate ownership of the pipe work north of Orchard Place and confirm maintenance is carried out, to ensure its flow is maintained. CCTV of pipe may be required to ensure pipe is still in working order and to try and discover possible cause of water bubbling up.
- SCC highways to ensure regular maintenance is carried out in line with gully cleansing regime.
- Primary school to ensure gullies in the playground are regularly cleaned and maintained. CCTV inspection may be required to confirm pipes are still in working order.

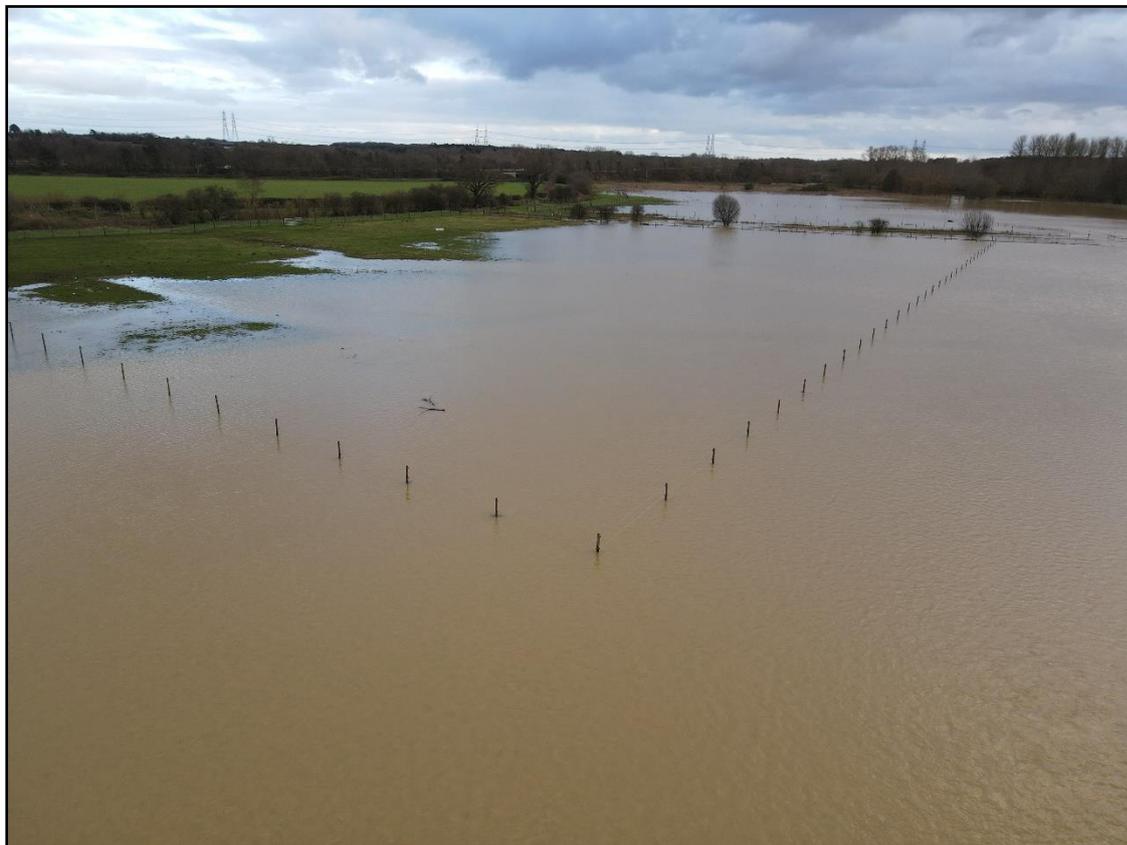
Image 1 - Flooding to pastureland in north Wickham Market

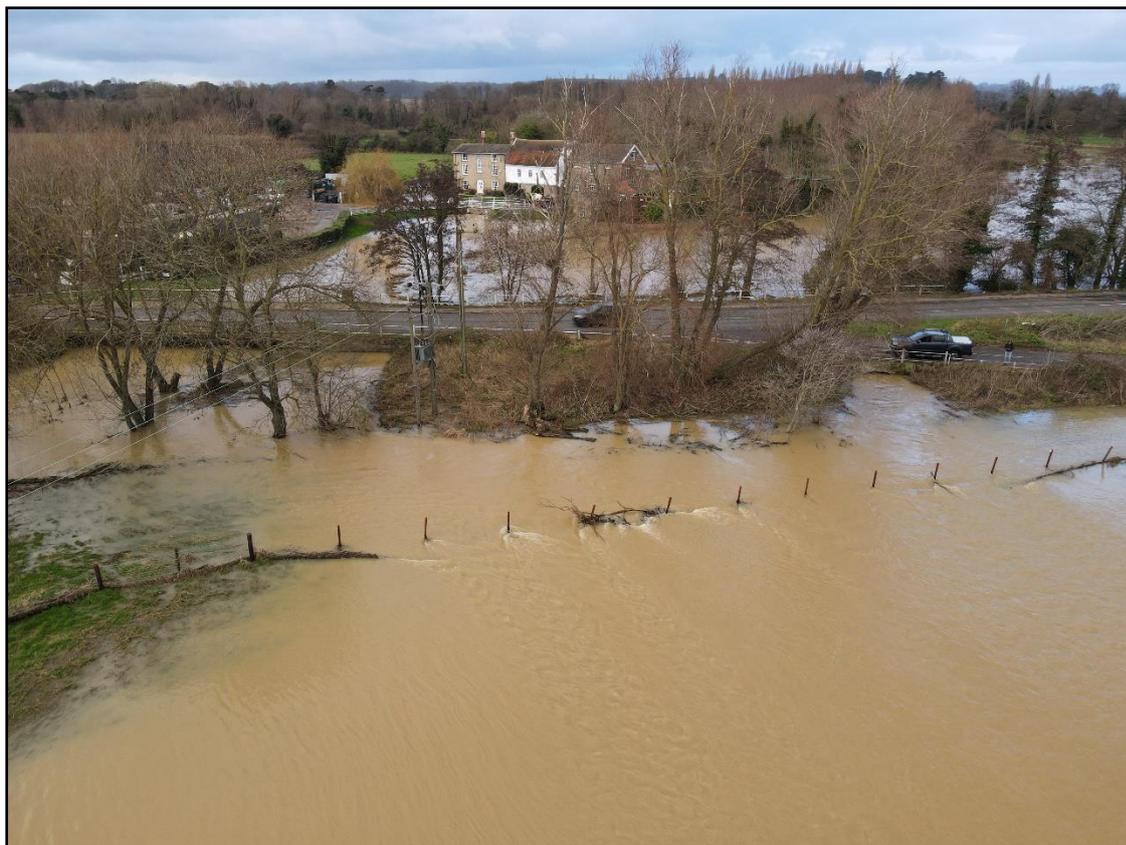
Image 2 - Wickham Market bridge

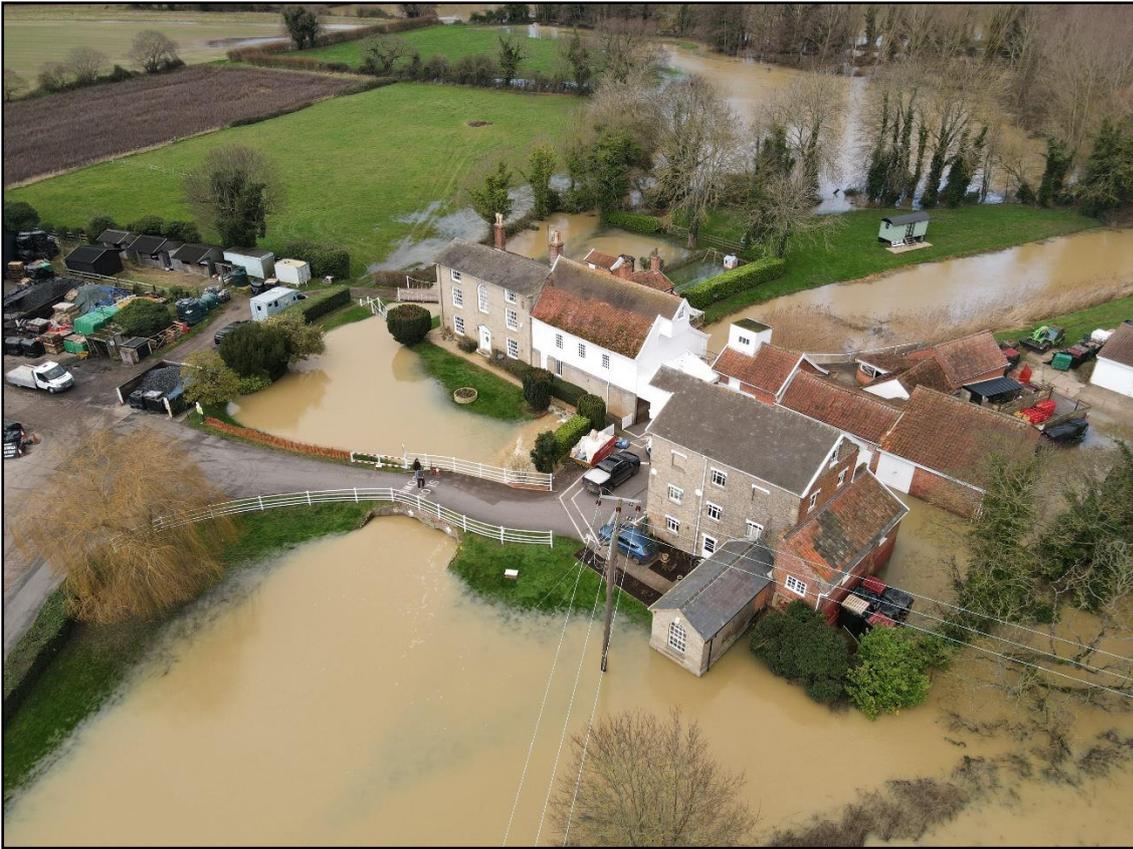
Image 3 - Deben Mills

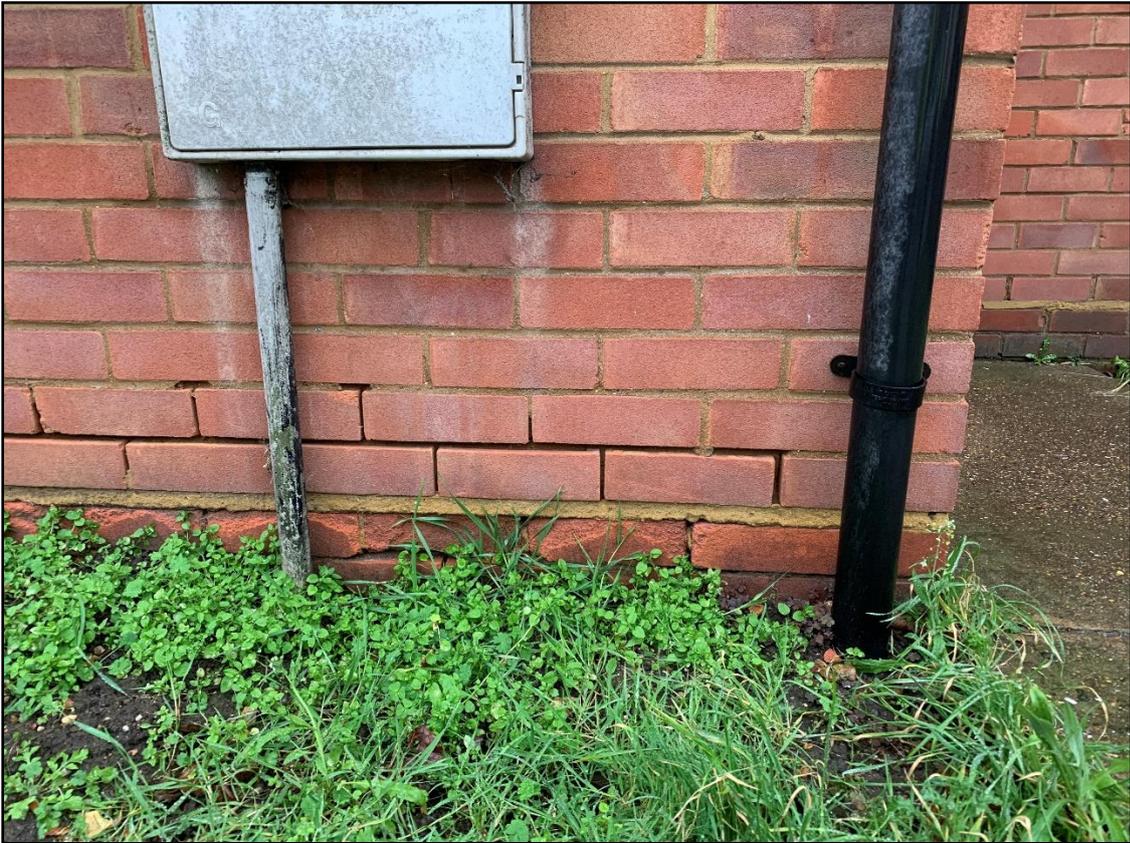
Image 4 – High water level marks post event showing erosion to brickwork

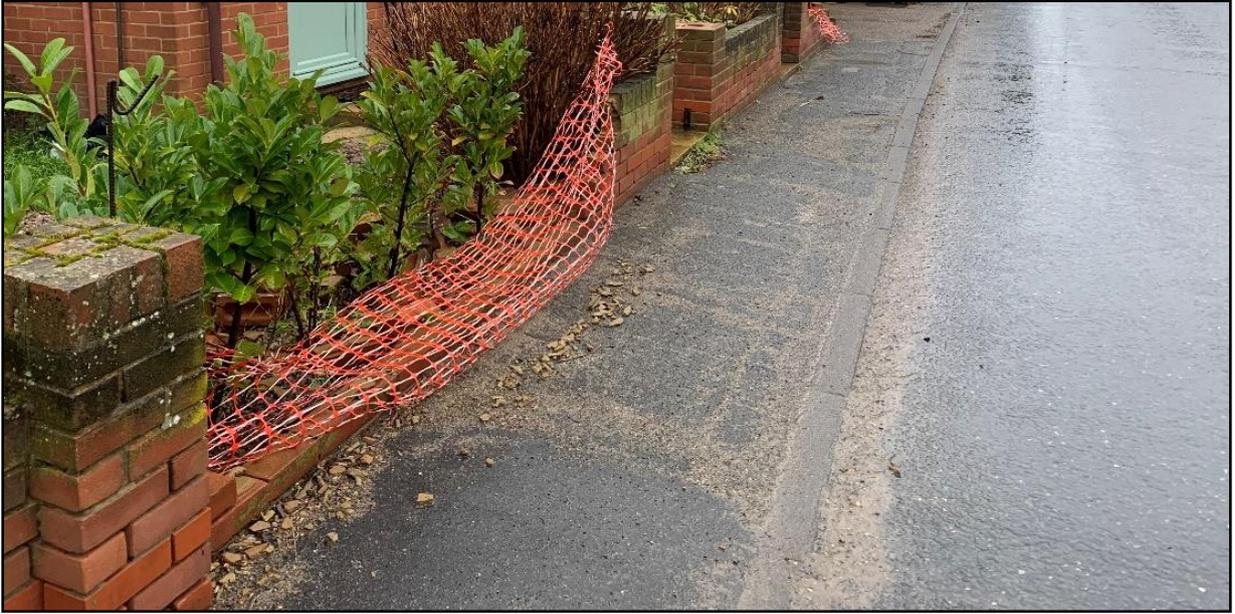
Image 5 - Post event damage

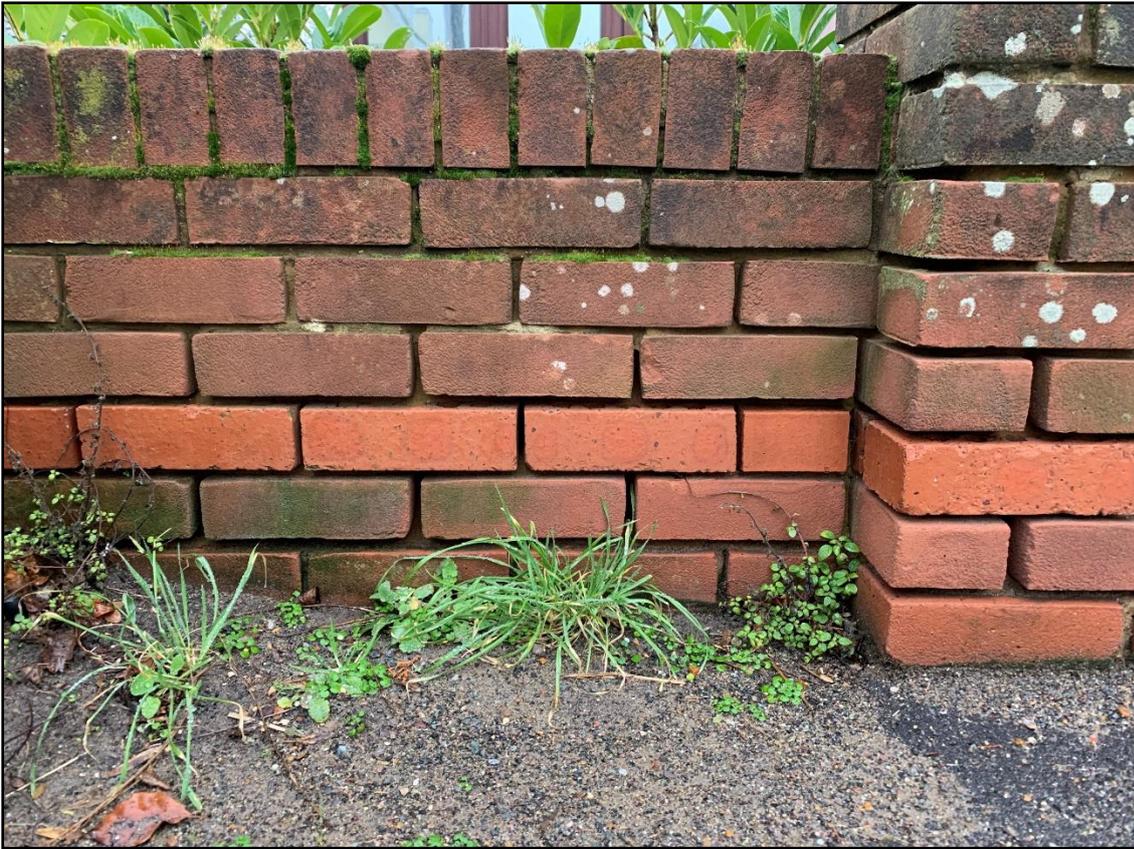
Image 6 - Post event damage

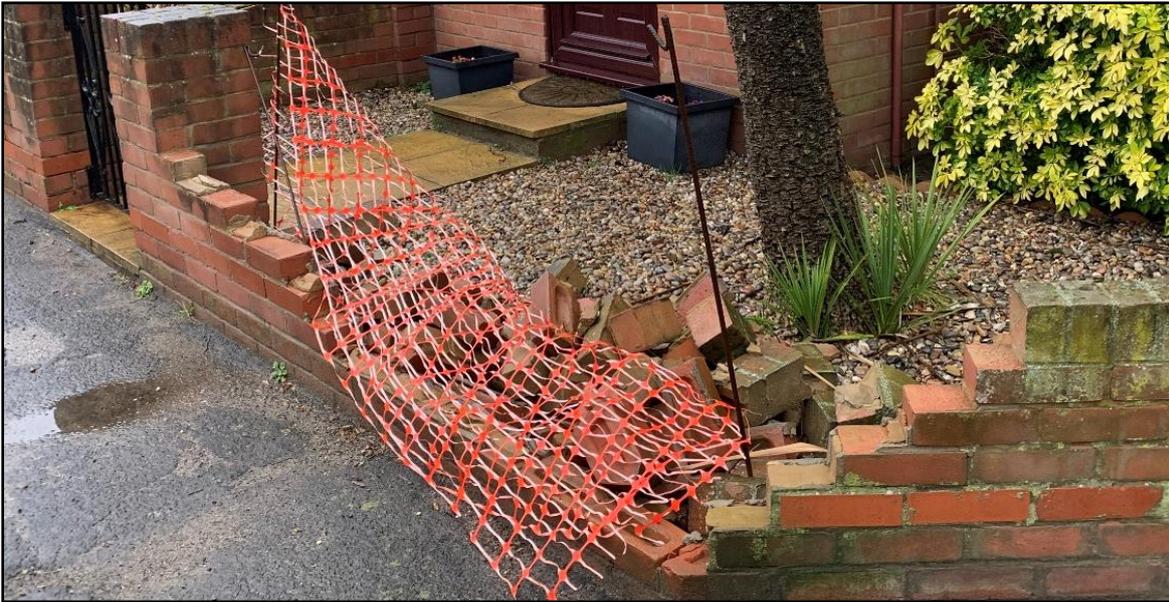
Image 7 - Post event damage
