Section 19 Flood and Water Management Act 2010

Wickham Market Flood Investigation - Storm Babet October 2023

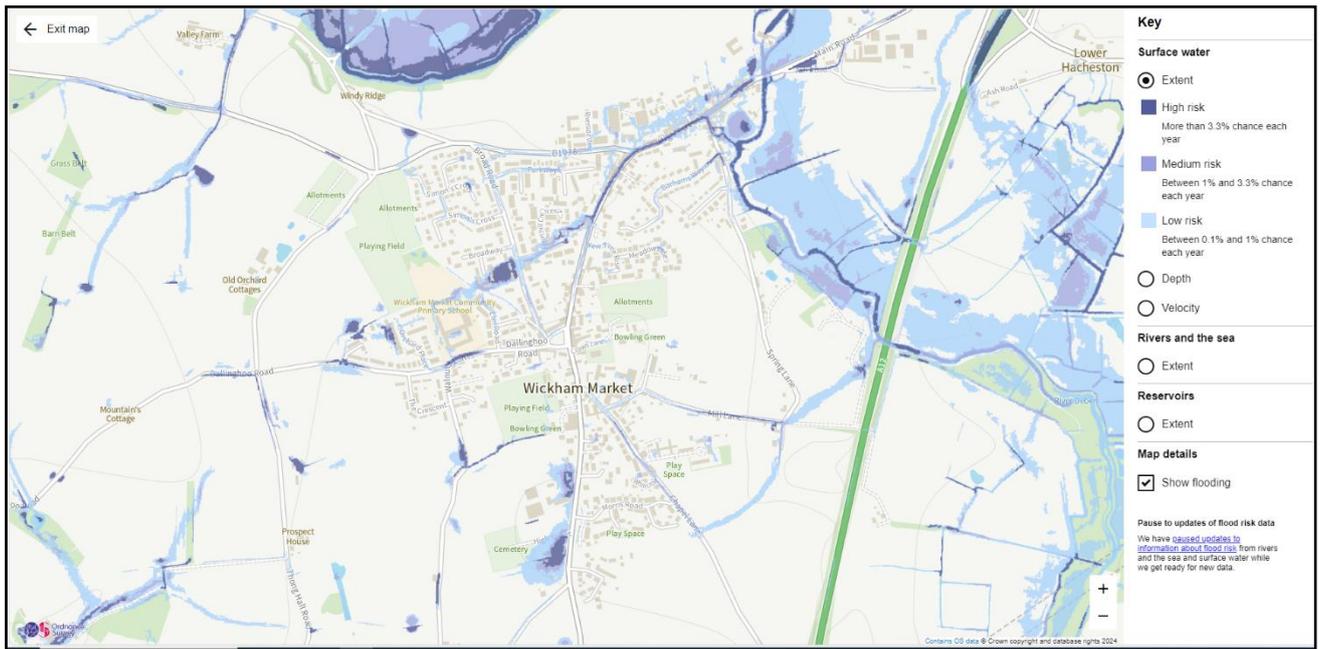
Figure 3 - Predicted pluvial (surface water) flood risk

Wickham Market is identified as being at significant flood risk from more than one source of flooding, and this is demonstrated in the following mapping information. The town is at risk of both fluvial (from the Deben, designated Main River) and pluvial (surface water run-off from surround land and ditches) flooding. The main areas predicted to be at risk coincide with the locations affected during Storm Babet, i.e. High Street, Spring Lane, Broad Road, Broadway, Orchard Place and Mill Lane.

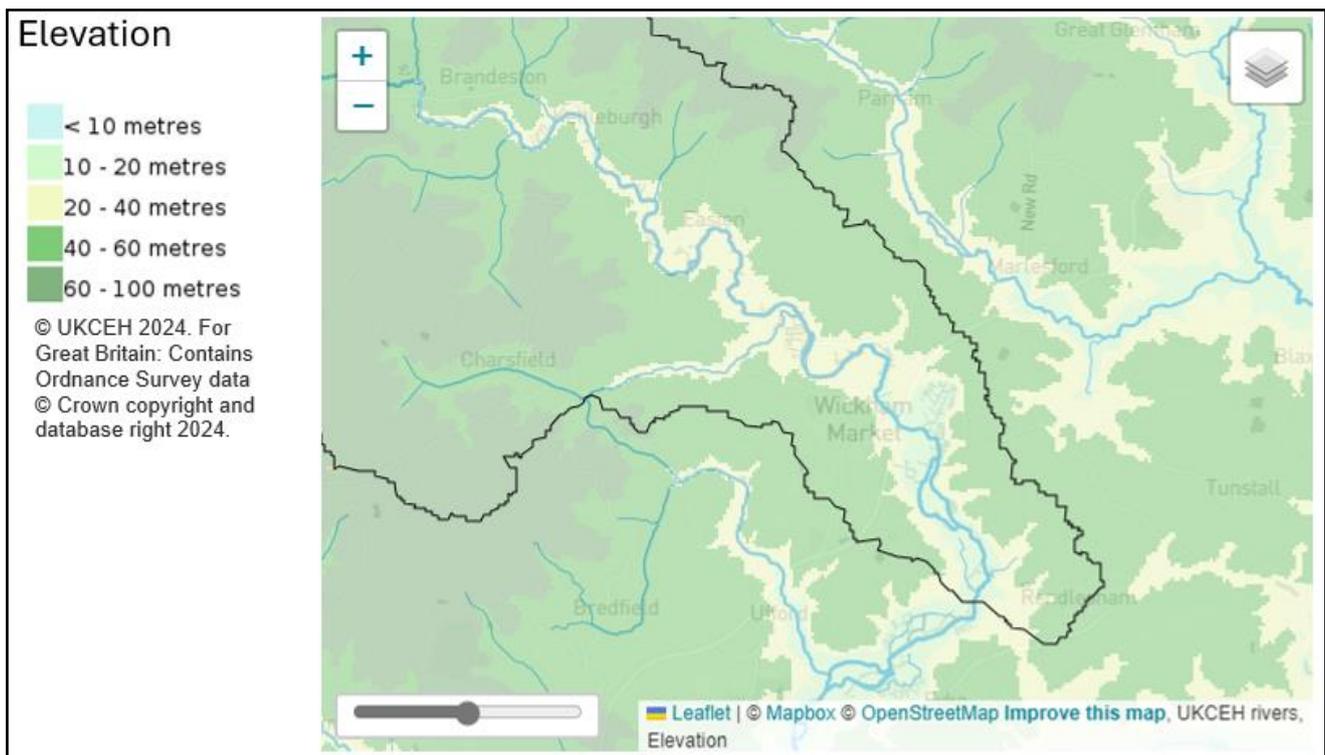
Figure 5 - Topography showing the catchment boundary surrounding Wickham Market

Areas of Wickham Market are low lying, with reasonably steep surrounding topography. A small proportion of the village in the northeast corner is low lying and noticeably shallower than central and western parts of the town (Figure 5). This area will be susceptible to overtopping from the River Deben compared to other locations. Other regions will be more susceptible to flooding from surface water runoff during heavy rainfall.

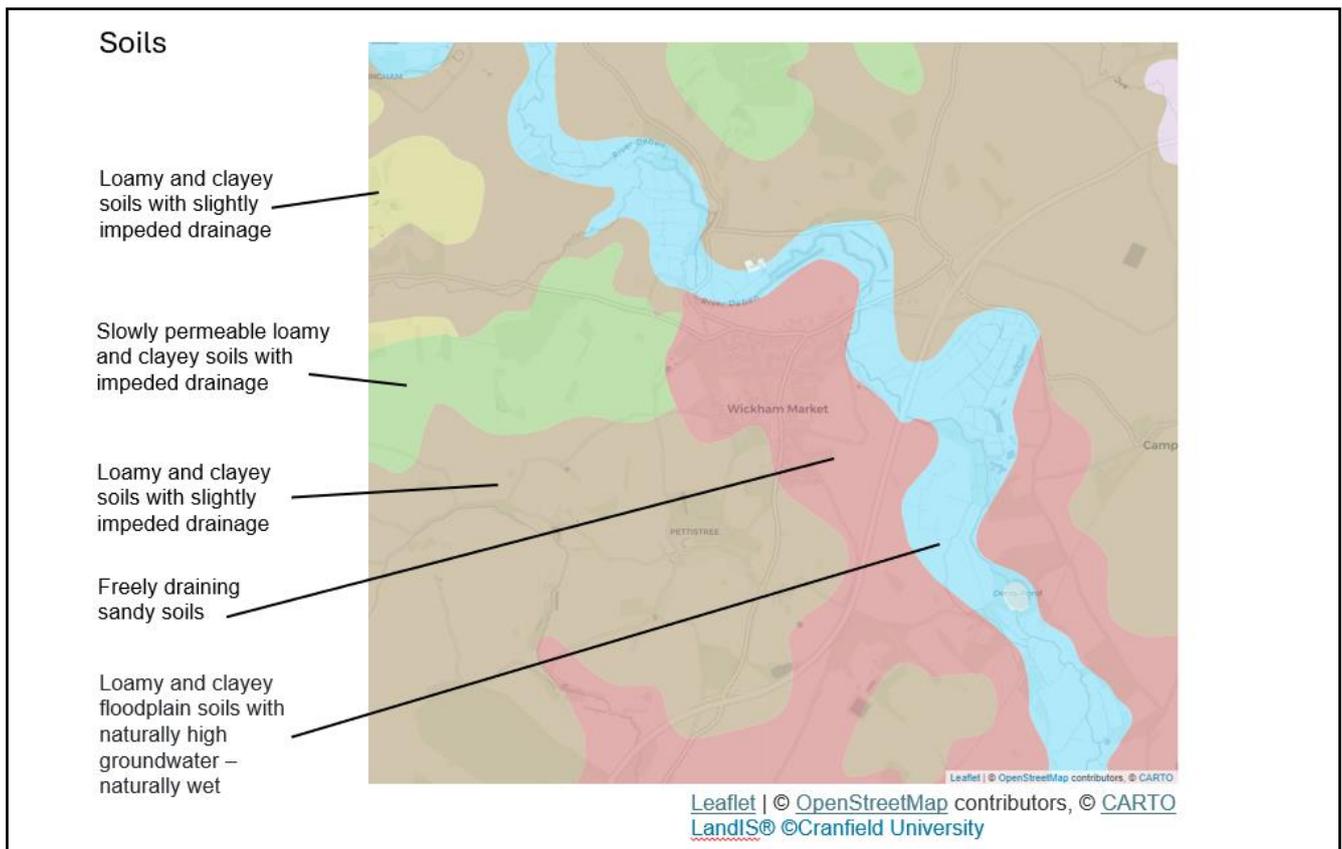
Figure 6 - Map of soils surrounding Wickham Market

The topography, geology and soils within the catchment make Wickham Market susceptible to extreme rainfall events, with high run off and limited permeability in much of the catchment. Saturated ground and high rainfall, like that of Storm Babet, will further emphasise the vulnerability of the town and localised flooding could be experienced.

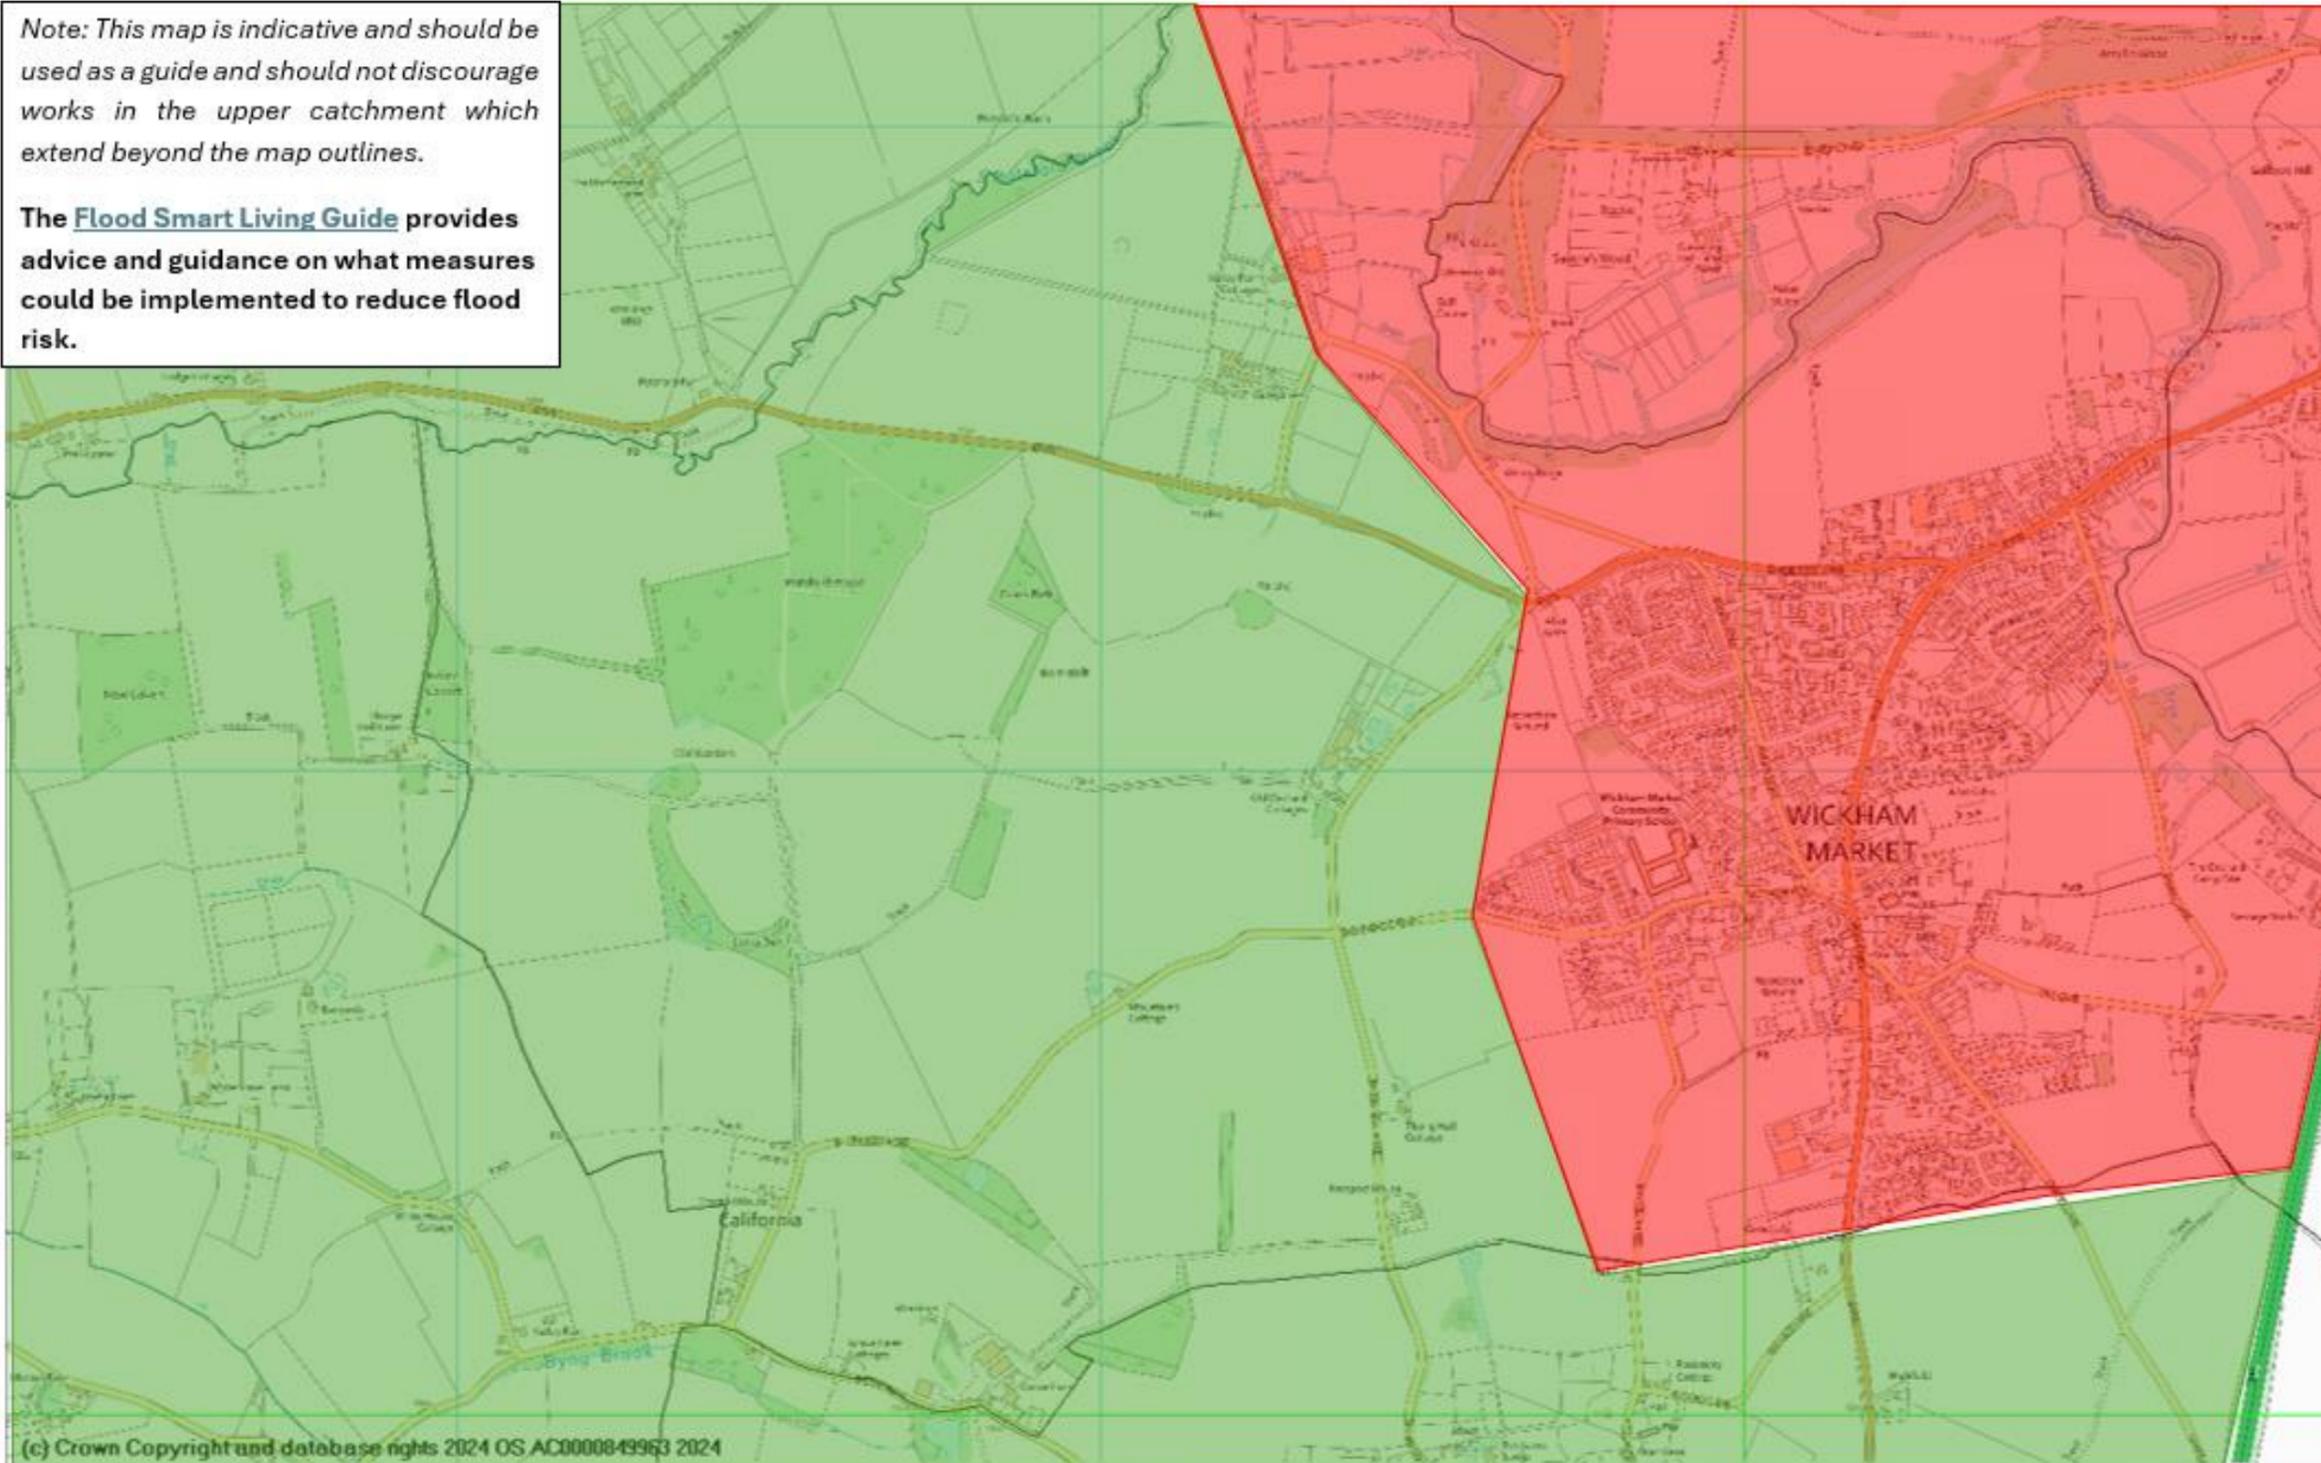
Red – Urban locations where watercourses should be kept clear and water free flowing.

These locations are vulnerable to flood risk and are where the most impact is experienced during an event. Drainage features are constrained with limited space for water and overwhelming of features may lead to flooding. Important to ensure water can flow through the systems with limited restrictions.
